## MEMORANDUM

<b>DATE:</b>	September 12 <sup>th</sup> , 2016
<b>FROM:</b>	Eric Lancaster
<b>SUBJECT:</b>	Weekly Progress Report @ Gold King
<b>TO:</b>	Kerry Guy

**Project:** Gold King Interim Water Treatment Plant (IWTP)

**Report No.:** 35

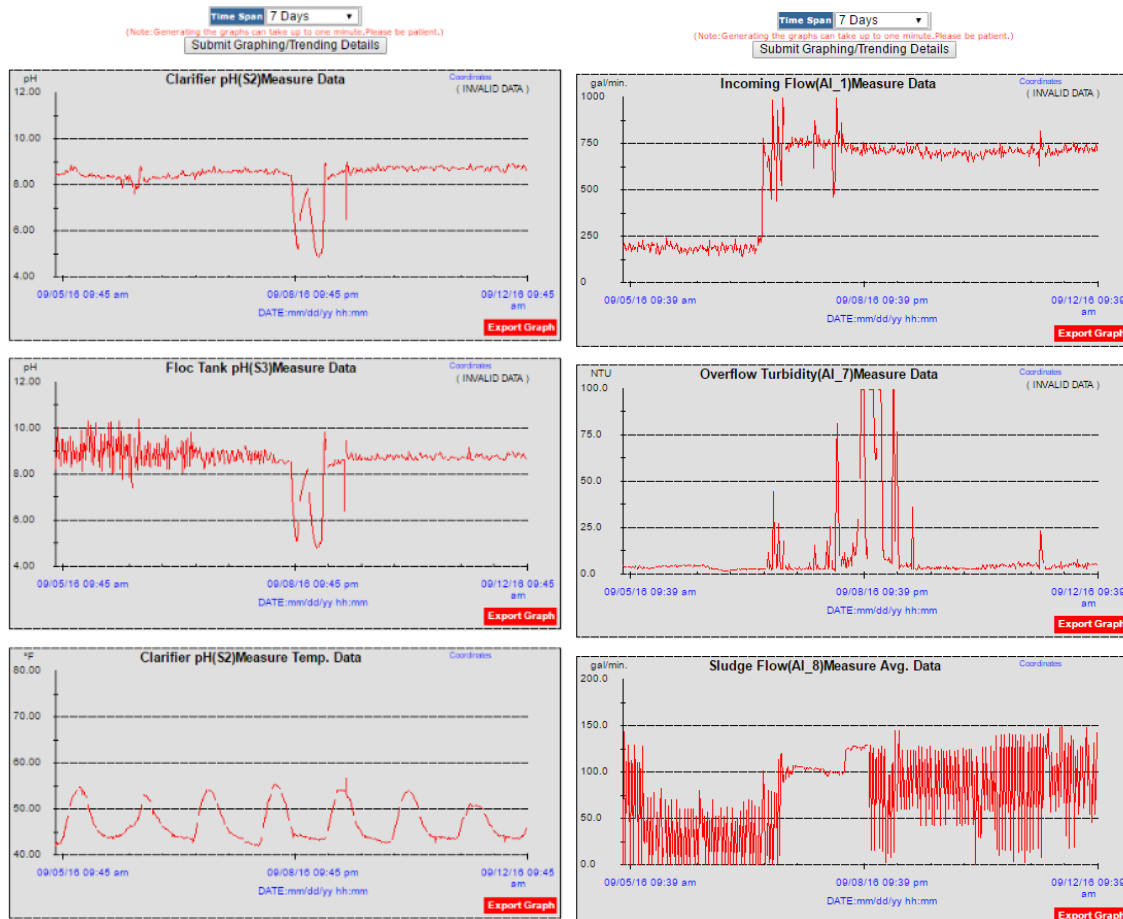
- The following graphs provide trending information during the previous 7 days. The dataloggers collect control information from the Lime Circuit (left) and Flow Circuit (right) Programmable Logic Controllers (PLCs) at the Gold King IWTP. Over the reporting period (9/5 – 9/12/2016 inclusive) Alexco treated 7.26 million gallons at an average flow rate of 720 gpm.

- Please note: Several days each week, the Alexco operators check the pH at both the flocc tank and clarifier discharge. During this time, the probe is placed in vinegar (acid), and three pH buffers – 4, 7, and 10. While the probe is in the acid/buffer, the datalogger may capture one of those points for tracking purposes, which explains the occasional pH spikes seen on the graph. In addition, instantaneous spikes of the Overflow Turbidity Meter are associated with routine cleaning, which can cause the meter to spike temporarily up to 100 NTUs.
- Over the reporting period (8/29 – 9/5/2016 inclusive) Alexco treated 6.8 million gallons at an average flow rate of 675 gpm.
- A pH sample from the IWTP inlet on 8/31 measured 3.74.
- A pH sample from the IWTP inlet on 9/2 measured 3.60.
- A pH sample from the IWTP inlet on 9/9 measured 3.66.

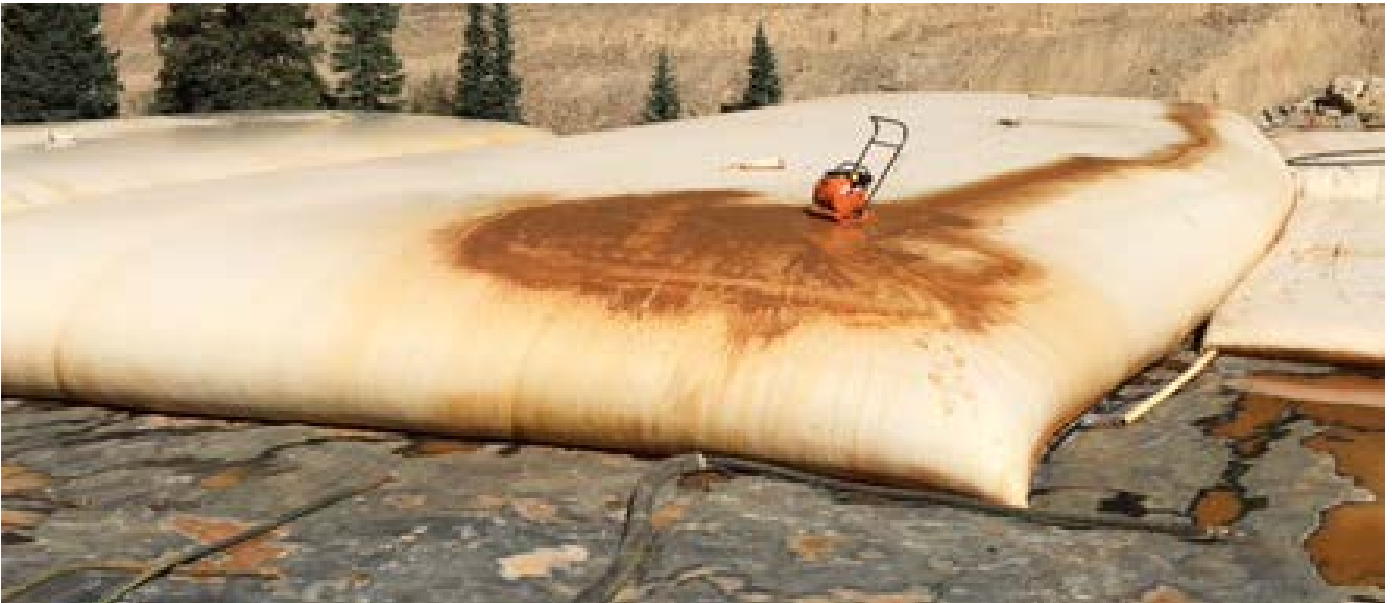
Photo 2: Vibratory plate compactor was used to encourage the release of extra water held within the bag with minimal success.

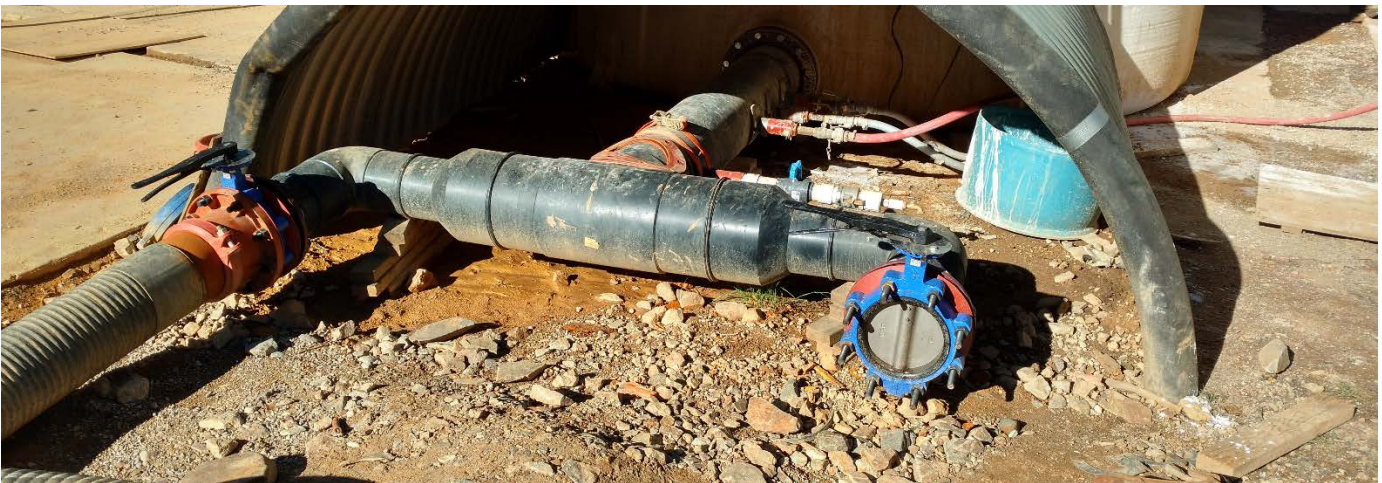
- Since 9/1/2016, one of the 8" HDPE lines connected to the Reactor Tank has been shut-off and disassembled (see Photo 3). A small leak was discovered in the mild steel fitting, which was caused by low pH water just upstream of the shut-off valve. The system is continuing to function properly, but the pipeline between Pond 2 and the Reactor Tank seems to cause flow spikes and surging at times. This can be seen in the turbidity graph on 9/8 and 9/9. However, at this time the flow surging does not seem to be a problem. The fitting will be replaced during the reconfiguration of the Reactor Tank.

Photo 3: Only one 8" HDPE line is currently connected to Pond 2.
